Structural Research Series No. 622

SEISMIC BEHAVIOR OF BRIDGE COLUMN NON-CONTACT LAP SPLICES

A Report to the Illinois Department of Transportation
on Project IHR-330

June 1998

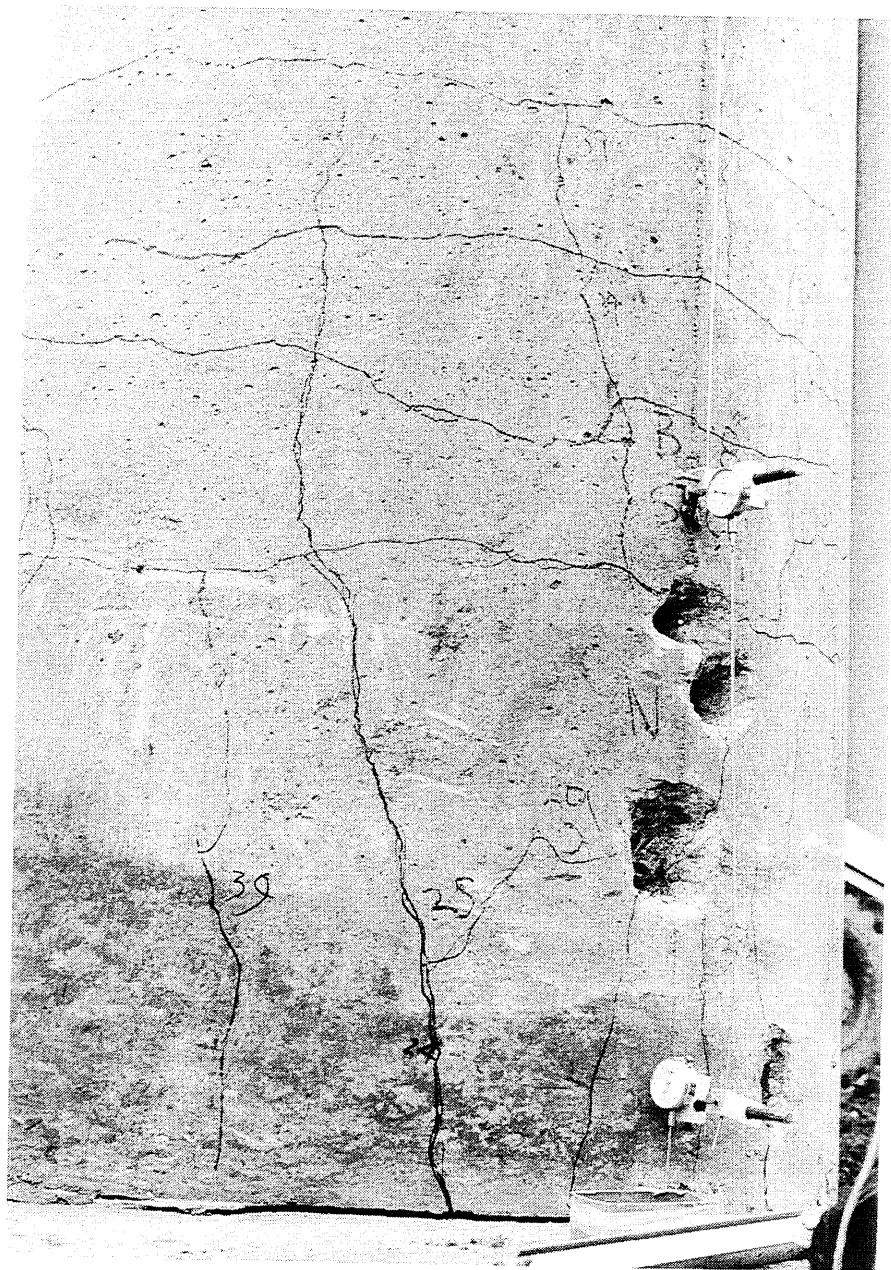
Fig. 3.9 More Vertical Cracks on the Column Bottom Part
